## **Chapter 2 DESCRIPTION AND TIMELINE OF THE INCIDENT**

### **2.1 INTRODUCTION**

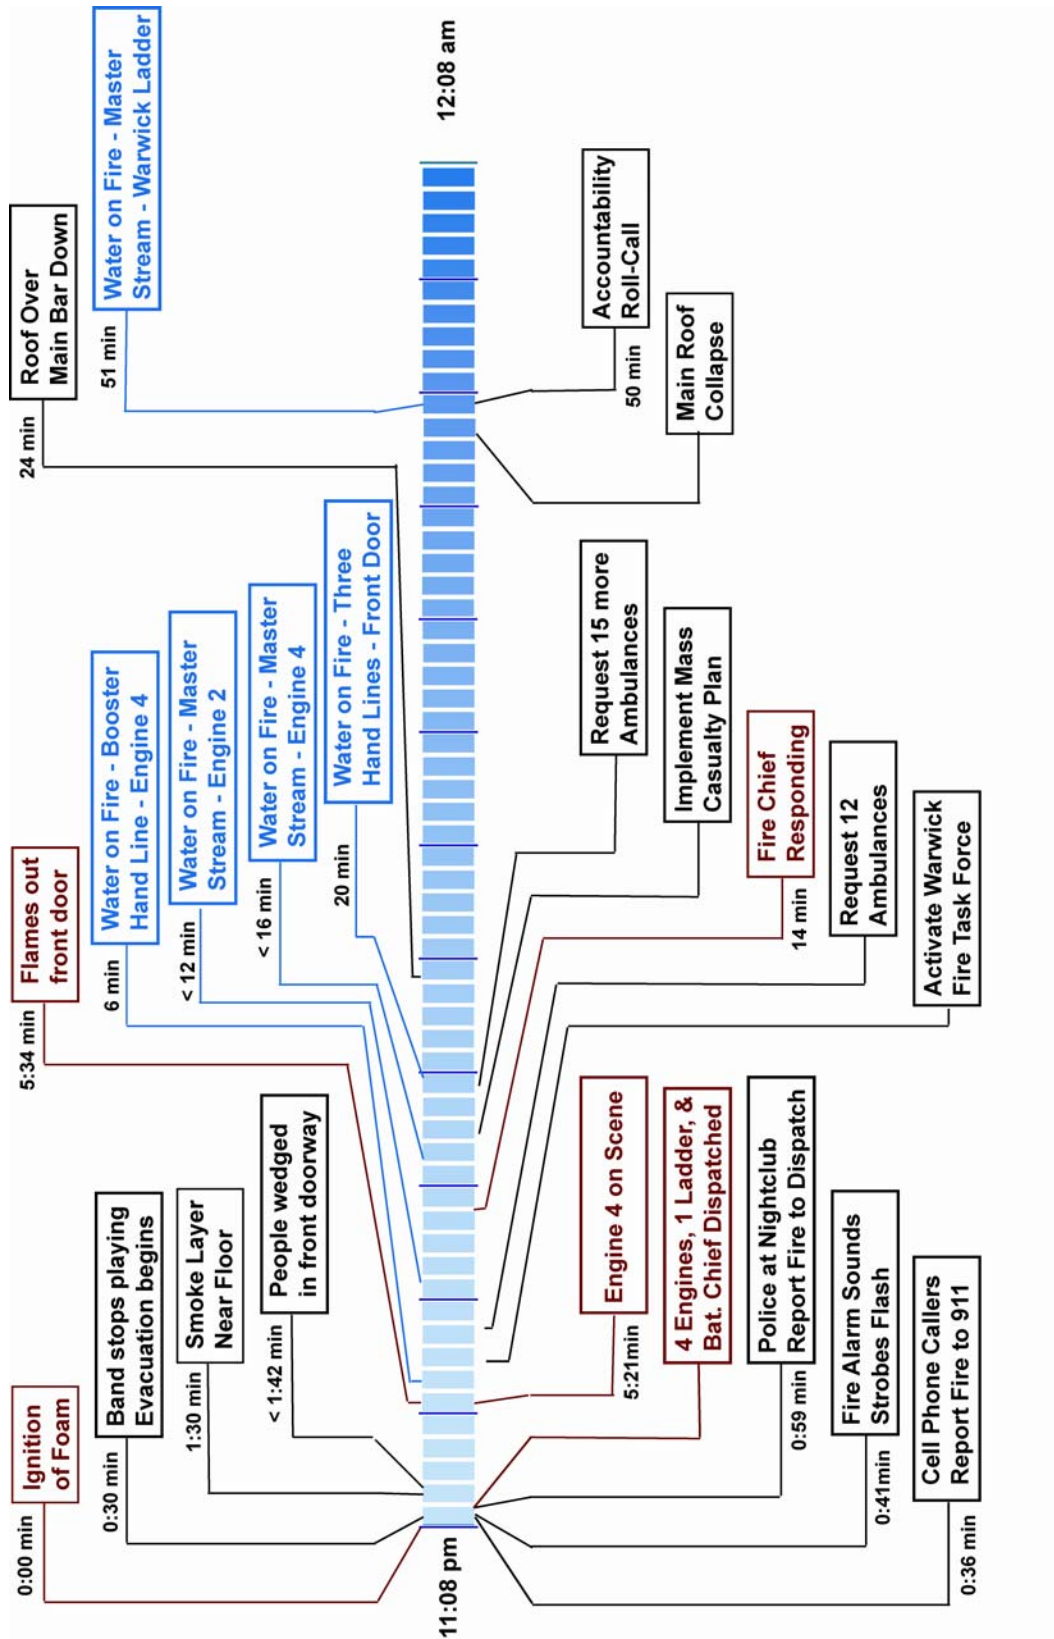
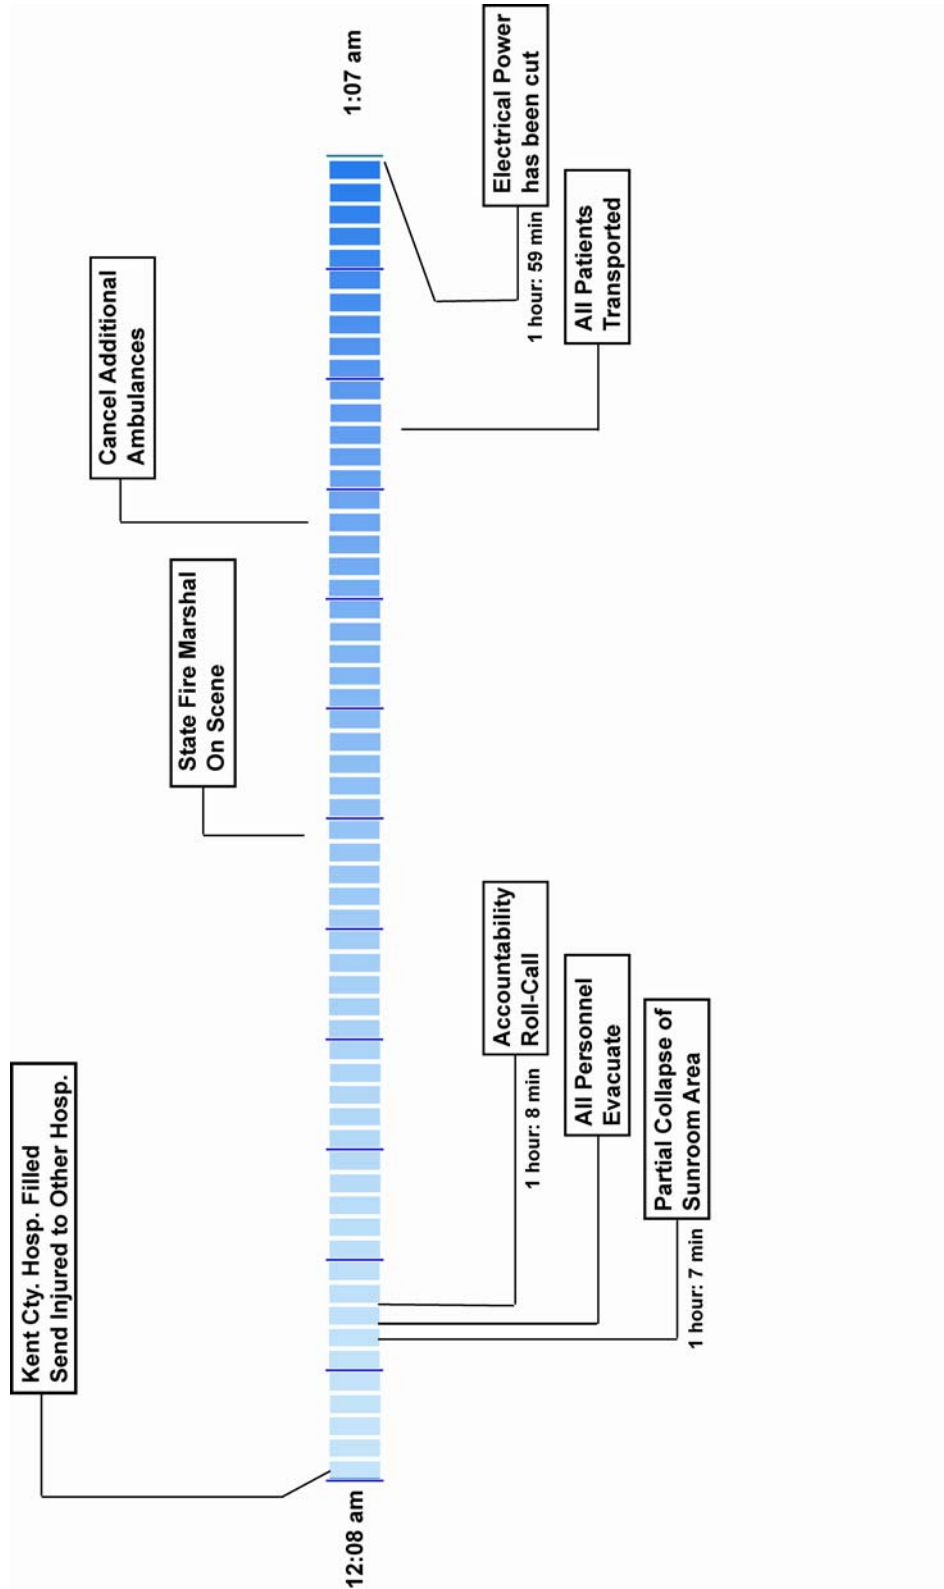
An overview timeline is shown in Figures 2-1a and 2-1b. Detailed events are summarized in Table 2-1.

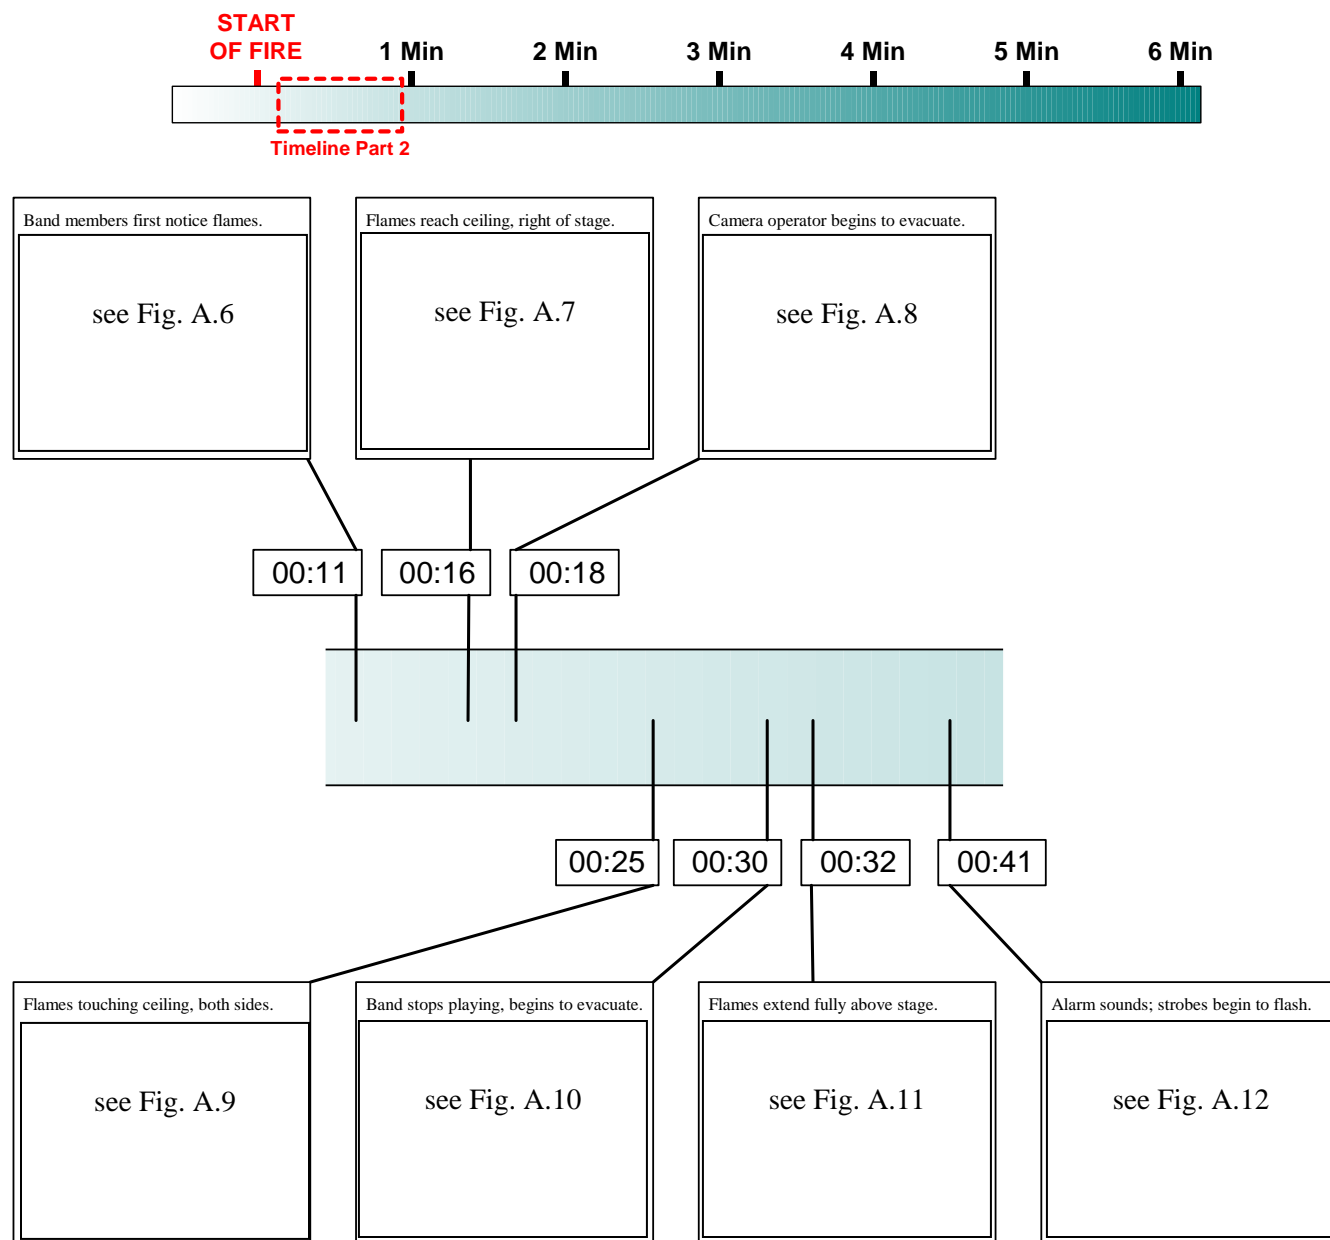
**Figure 2-2b. Evacuation Timeline (10 seconds to 50 seconds after ignition).**

the bulk of the crowd had begun the evacuation process. At 41 seconds the fire alarm could be heard and the strobe seen on the video. (See Fig. 2-2b.)

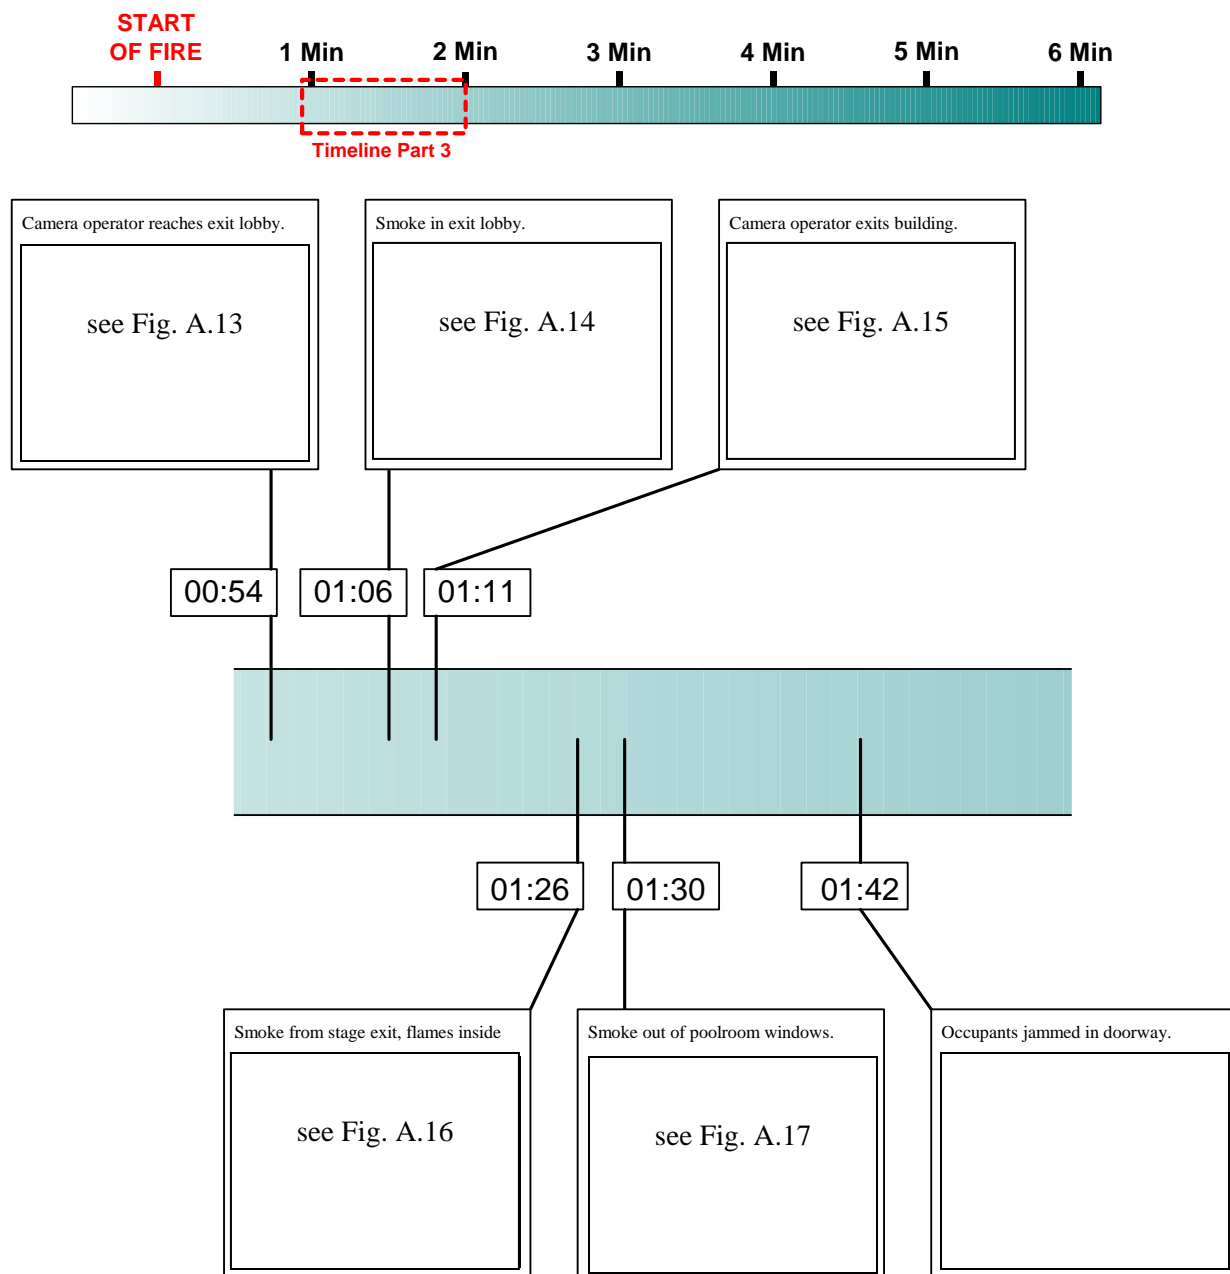
**Figure 2-2c. Incident Timeline (50 seconds to 2 minutes after ignition).**

The videographer made his way to the exit lobby while continuing to capture the movement of the crowd leaving the area around the dance floor. As seen in Fig. 2-2c, he exited the building at 1 minute 11 seconds (fire time) along with a steady stream of occupants. Sometime estimated to be around 1 minute 30 seconds after ignition of the foam, the front exit became blocked with people, and occupants could be seen breaking windows and escaping from the poolroom/sunroom. The result of the crowd crush at the front exit was captured on the video at 1 minute 42 seconds (Fig. 2-2c). The latest time recorded for an occupant escaping from inside the main bar (through a window) was at 4 minutes 8 seconds; however, people stuck in the front entrance are seen in the video to have escaped as late as 5-1/2 minutes into the fire, just before the fire department ran its first hose line (Fig. 2-2d). (One patron claimed to have been pulled from the bottom of the pile by a firefighter considerably later, but this has not been confirmed by the NIST investigation.)
